**Flood Control Project Maintenance  
Levee Inspections**

## Maintenance Issue Types Only, Levee Inspection Report By Mile - Spring 2017

### Reclamation District No. 0010 Honcut

Waterway	Bank	Unit Miles	Inspection Start/End	Inspector
Unit No. 01 Simmerly Slough	Right	7.65	04/11/2017 04/11/2017	Sterling York

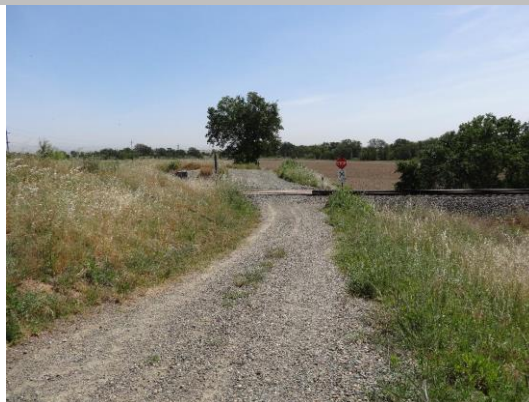
Photo 1 of 3 : UCIP\_SP\_2017\_27791\_51501.jpg

LM Start	0.00	Rating **	M	Issue No.	68
LM End	0.00	Issue Type +	Ma	Location *	N/A
Category	Supplemental		GPS Latitude/Longitude		
			Start	End	
Item	DWR UCIP LMA Responsibility		39.169234 °	39.169234 °	
			-121.586203 °	-121.586203 °	
DWR ID					
Comment Code					
Inspector Comment					
FS_ID:27791 DS_ID:21268 EP_NO: N/A Repair Type: Non-Urgent Crossing Status: Found UCIP Comments: Vegetation has been cleared from slope. This crossing is referenced in the USACE Periodic Inspection as item USACE_CESPK_HON1_2013_p_0158. FIELD_STRUCT_DESC: 24-inch CM drainpipe through the levee, 30.0 feet below the crown. Flap gate on the waterward end. Slide gate on the landward end. Concrete saddle and apron on waterward side. (USACE-1955). This entry matches the Drainage or Irrigation Structure referenced in O&M manual (Station 1+00). FS Date: 4/29/2013

View of levee crown looking downstream.

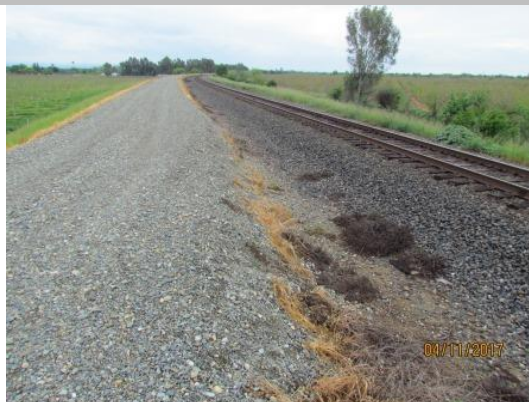
Photo 1 of 1 : SP\_2017\_RD0010\_163\_31\_20170425\_00098.jpg

View of well maintained annual grasses on the waterside, Spring 2017.

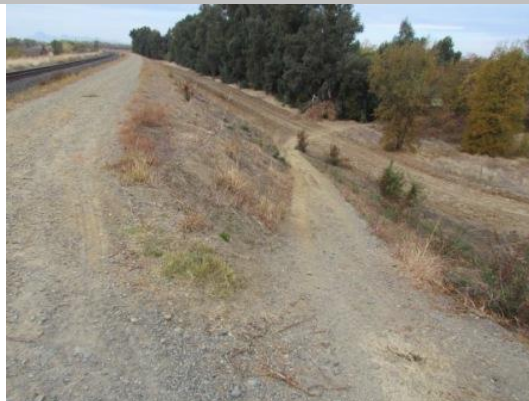
Photo 1 of 2 : SP\_2017\_RD0010\_163\_48\_20170316\_00017.jpg

LM Start	0.72	Rating **	M	Issue No.	48
LM End	0.72	Issue Type +	Ma	Location *	LS
Category	Earthen Levee			GPS Latitude/Longitude	
				Start	End
Item	Slope Stability			39.161198 °	39.161198 °
				-121.597102 °	-121.597102 °
DWR ID	DWR_RD0010_01_f_2013_48				
Comment Code					
S3 : Repair the levee slope damaged by vehicle traffic and prevent access where possible.					
Inspector Comment					
Ramp is caused by constant ATV use on levee slope. Fall 2016.

This photo was taken from the crown looking down the landward slope at an ATV access road that has been formed over time to provide access to the waterward side. Fall 2013.

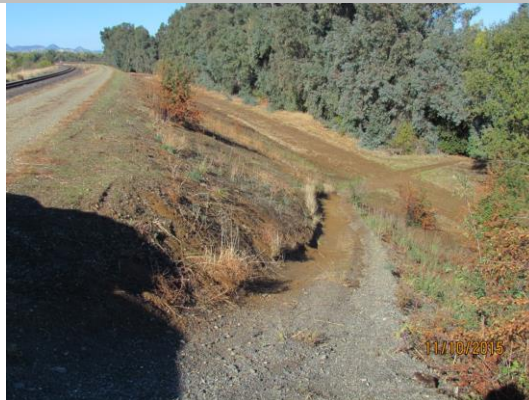
Photo 2 of 2 : SP\_2017\_RD0010\_163\_48\_20170316\_00018.jpg

View of the slope stability on the landward side of the levee looking downstream. Fall 2015.

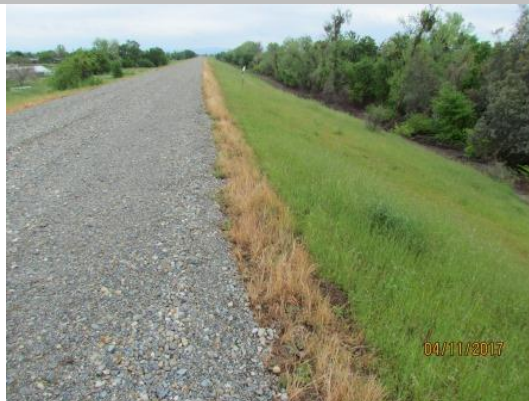
Photo 1 of 1 : SP\_2017\_RD0010\_163\_30\_20170425\_00094.jpg

View looking upstream of the annual grass that need to be maintained, the shoulder has been sprayed. Spring 2017.

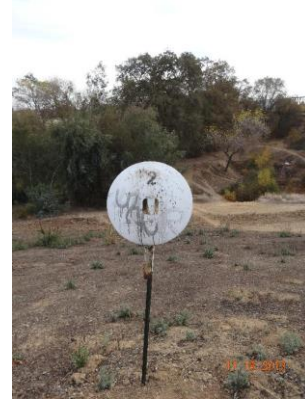
Photo 1 of 3 : UCIP\_SP\_2017\_50058\_51415.jpg

FS\_ID:50058  
DS\_ID:21258  
EP\_NO: N/A  
Repair Type: Non-Urgent  
Crossing Status: Found  
UCIP Comments: 7/01/2016 Gate has been repaired--WS gate is functional. LS gate still needs new stem for the gate to properly function--stem is bent. USACE's PI issue references permit number 13710 this is incorrect permit is associated with DS\_ID 21259 (CLM 0.767). (DWR UCIP - omagana)4/29/2013 Damaged flap gate on waterward side and damaged stem on screw gate on landward side. Need to contact owner to determine if crossing is still active. If crossing is still in use owner will need to address damage on flap gate and screw gate. If crossing is no longer in use owner will need to contact the CVFPB to comply with Title 23. This crossing is referenced in the USACE Periodic Inspection as item USACE\_CESPK\_HON1\_2013\_p\_0053 and 0057. (DWR UCIP - omagana)  
FIELD\_STRUCT\_DESC: 24-inch corrugated metal drainage pipe through the levee, 31 feet below the crown. Two corrugated metal cutoff walls around pipe and concrete headwall at both ends. Flap gate is located on the waterside (WS) end. Slide gate is located on the landside (LS) end. Pipe discharges into 6-foot concrete splash apron located on the WS. [Additional Reference(s): DWR Levee Log, 2005. USACE Sacramento O&M Manual Unit No. 151, May 1953, Station 46+60].

View of WS--Marker indicates crossing is labelled as 2.

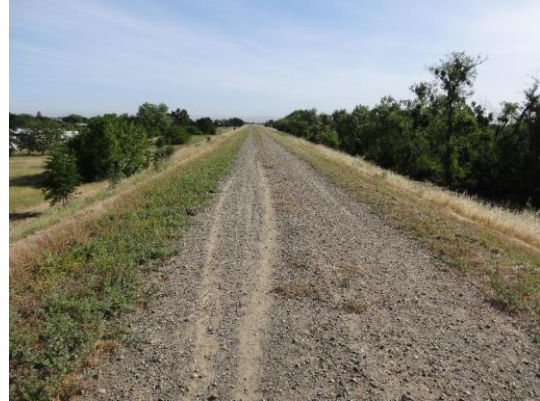
Photo 2 of 3 : UCIP\_SP\_2017\_50058\_51410.jpg

FS\_ID:50058  
DS\_ID:21258  
EP\_NO: N/A  
Repair Type: Non-Urgent  
Crossing Status: Found  
UCIP Comments: 7/01/2016 Gate has been repaired--WS gate is functional. LS gate still needs new stem for the gate to properly function--stem is bent. USACE's PI issue references permit number 13710 this is incorrect permit is associated with DS\_ID 21259 (CLM 0.767). (DWR UCIP - omagana)4/29/2013 Damaged flap gate on waterward side and damaged stem on screw gate on landward side. Need to contact owner to determine if crossing is still active. If crossing is still in use owner will need to address damage on flap gate and screw gate. If crossing is no longer in use owner will need to contact the CVFPB to comply with Title 23. This crossing is referenced in the USACE Periodic Inspection as item USACE\_CESPK\_HON1\_2013\_p\_0053 and 0057. (DWR UCIP - omagana)  
FIELD\_STRUCT\_DESC: 24-inch corrugated metal drainage pipe through the levee, 31 feet below the crown. Two corrugated metal cutoff walls around pipe and concrete headwall at both ends. Flap gate is located on the waterside (WS) end. Slide gate is located on the landside (LS) end. Pipe discharges into 6-foot concrete splash apron located on the WS. [Additional Reference(s): DWR Levee Log, 2005. USACE Sacramento O&M Manual Unit No. 151, May 1953, Station 46+60].

View of levee crown looking downstream.

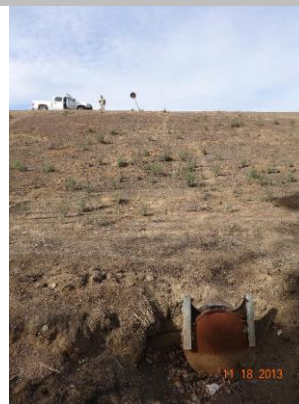
Photo 2 of 3 : UCIP\_SP\_2017\_27748\_51450.jpg

FS\_ID:27748  
DS\_ID:21261  
EP\_NO: N/A  
Repair Type: No Action Needed  
Crossing Status: Found  
UCIP Comments: No signs of damage to levee present during inspection. This crossing is referenced in the USACE Periodic Inspection as item USACE\_CESPK\_HON1\_2013\_p\_0037 and 0040.  
FIELD\_STRUCT\_DESC: 24-inch CM drainpipe through the levee, 29.5 feet below the crown. Two CM cutoff walls around pipe on both ends. Slide gate on the landward end. Flap gate on the waterward end. Concrete headwall at the landward toe. (USACE-1955). This entry matches the Drainage or Irrigation Structure referenced in O&M manual (Station 37+66).  
FS Date: 4/29/2013

View of slope located on waterward side.

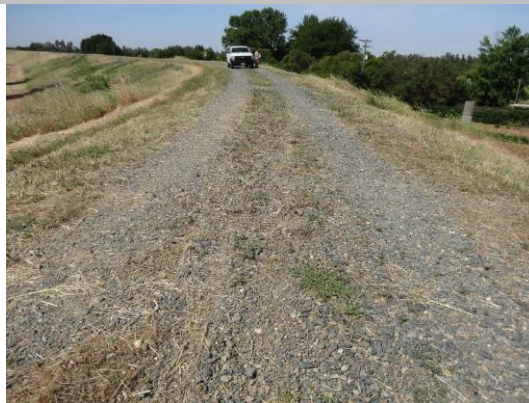
Photo 1 of 3 : UCIP\_SP\_2017\_24811\_44582.jpg

FS\_ID:24811  
DS\_ID:21264  
EP\_NO: N/A  
Repair Type: No Action Needed  
Crossing Status: Found  
UCIP Comments: This crossing is referenced in the USACE Periodic Inspection as item USACE\_CESPK\_HON1\_2013\_p\_0004.  
FIELD\_STRUCT\_DESC: [R.D. No 10 Drainage Plant] 16-inch steel pipe through the levee, 7.0 feet below the crown. Steel cutoff plate around pipe at center of levee. Siphon breaker on the landward slope. Flap gate on the waterward end. Pump in pit at landward toe, with steps along the landward slope. Saddle and splash apron (8-foot) at the discharge end of the pipe. Concrete headwall at landward toe. Metal shed on landward slope. (USACE-1955). This entry matches the Drainage or Irrigation Structure referenced in O&M manual (Station 13+88).  
FS Date: 4/29/2013

View of levee crown looking upstream of crossing.

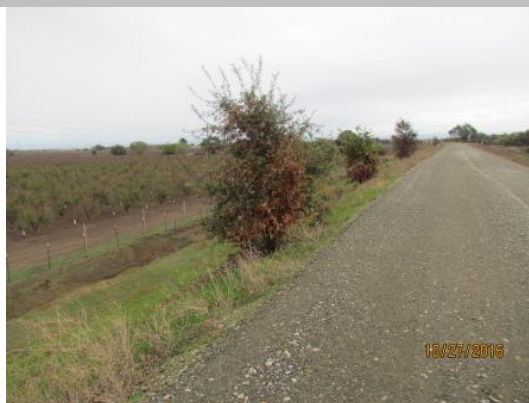
Photo 1 of 1 : SP\_2017\_RD0010\_163\_67\_20170316\_00034.jpg

View of a small tree that needs to be removed on the land side slope looking upstream. Fall 2016.

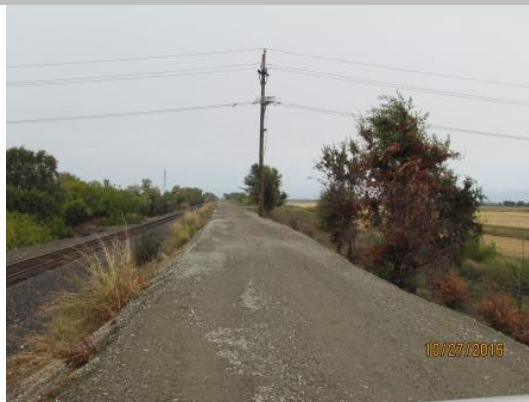
Photo 1 of 1 : SP\_2017\_RD0010\_163\_66\_20170316\_00033.jpg

View of a small tree that needs to be trimmed for visibility and access on the land side slope looking upstream. Fall 2016.

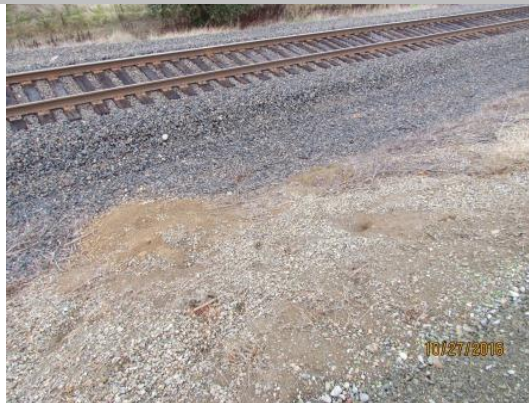
Photo 1 of 1 : SP\_2017\_RD0010\_163\_65\_20170316\_00032.jpg

View of squirrel holes on the landside, no rodent activity was observed. Fall 2016.

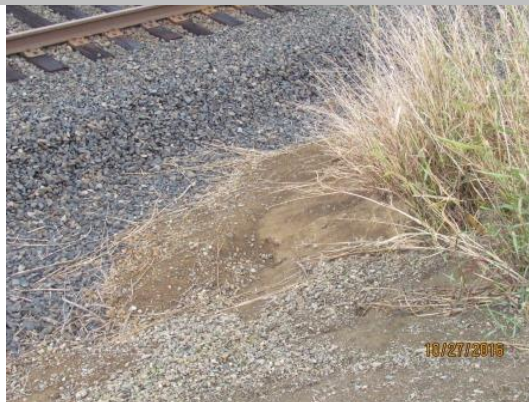
Photo 1 of 1 : SP\_2017\_RD0010\_163\_64\_20170316\_00031.jpg

View of squirrel holes on the landside, no rodent activity was observed. Fall 2016.

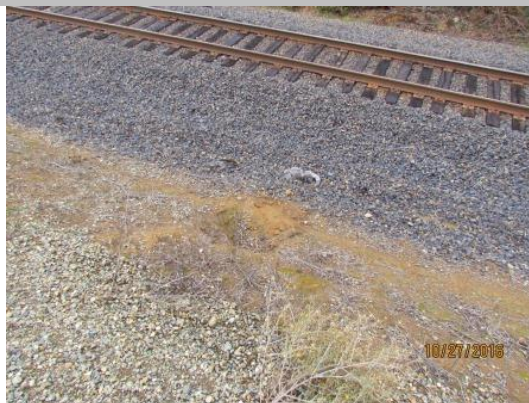
Photo 1 of 1 : SP\_2017\_RD0010\_163\_63\_20170316\_00030.jpg

View of squirrel holes on the landside, no rodent activity was observed. Fall 2016.

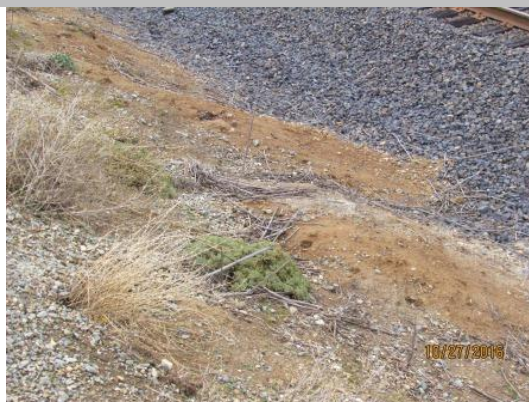
Photo 1 of 1 : SP\_2017\_RD0010\_163\_61\_20170316\_00029.jpg

View of squirrel holes on the landside slope and toe, no rodent activity was observed. Fall 2016.

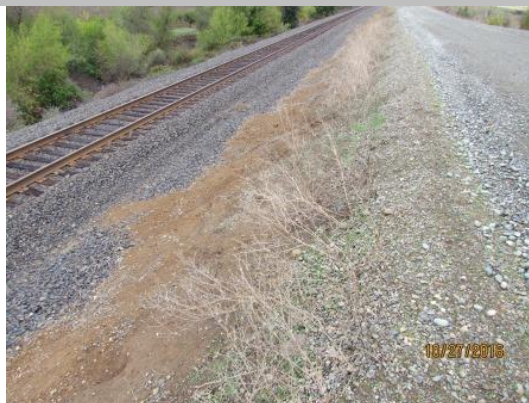
Photo 1 of 1 : SP\_2017\_RD0010\_163\_60\_20170316\_00028.jpg

View of squirrel holes on the landside slope and toe, no rodent activity was observed. Fall 2016.

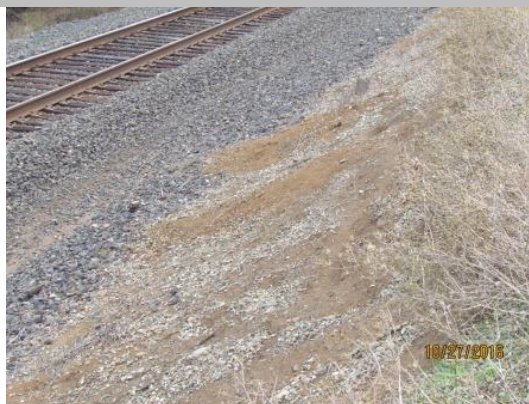
Photo 1 of 1 : SP\_2017\_RD0010\_163\_59\_20170316\_00027.jpg

View of squirrel holes on the landside slope and toe, no rodent activity was observed. Fall 2016.

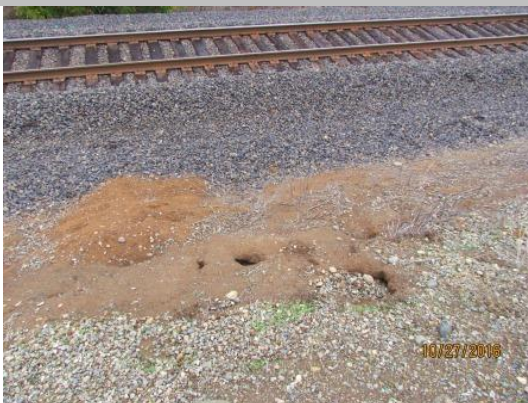
Photo 1 of 1 : SP\_2017\_RD0010\_163\_58\_20170316\_00026.jpg

View of squirrel holes on the landside slope and toe, no rodent activity was observed. Fall 2016.

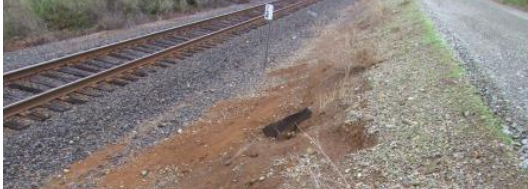
Photo 1 of 1 : SP\_2017\_RD0010\_163\_57\_20170316\_00025.jpg

View of squirrel holes on the landside slope and toe, no rodent activity was observed. Fall 2016.

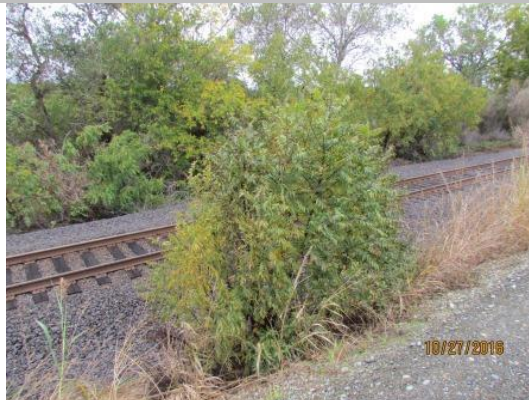
Photo 1 of 1 : SP\_2017\_RD0010\_163\_54\_20170316\_00023.jpg

View of small willow trees on the landside toe looking upstream. Fall 2016.

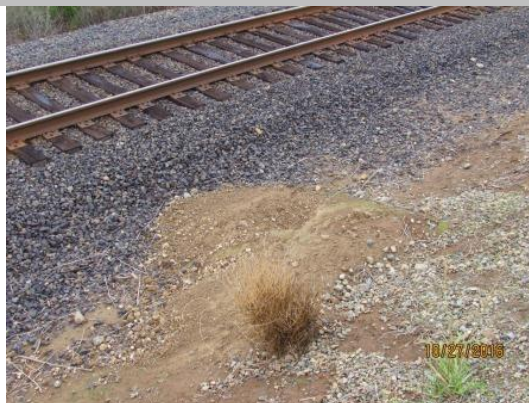
Photo 1 of 1 : SP\_2017\_RD0010\_163\_52\_20170316\_00022.jpg

View of squirrel holes on the landside slope and toe, no rodent activity was observed. Fall 2016.

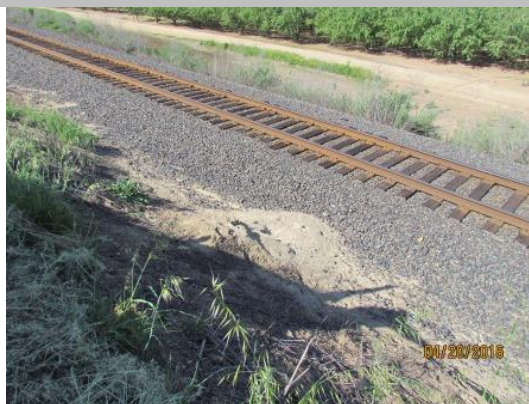
Photo 1 of 1 : SP\_2017\_RD0010\_163\_51\_20170316\_00021.jpg

View of large burrow on landside.

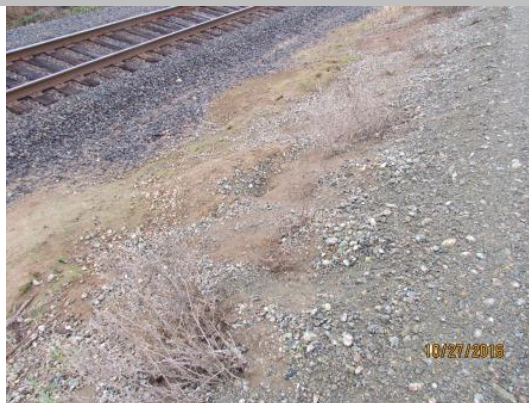
Photo 1 of 1 : SP\_2017\_RD0010\_163\_50\_20170316\_00020.jpg

View of squirrel holes on the landside slope and toe, no rodent activity was observed. Fall 2016.

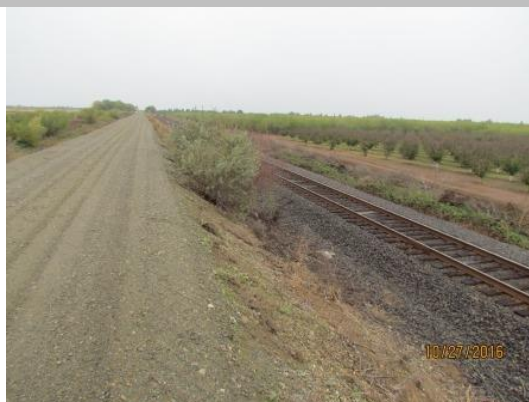
Photo 1 of 1 : SP\_2017\_RD0010\_163\_47\_20170316\_00016.jpg

View of a small willow tree that should be removed on the landside looking down stream. Fall 2016.

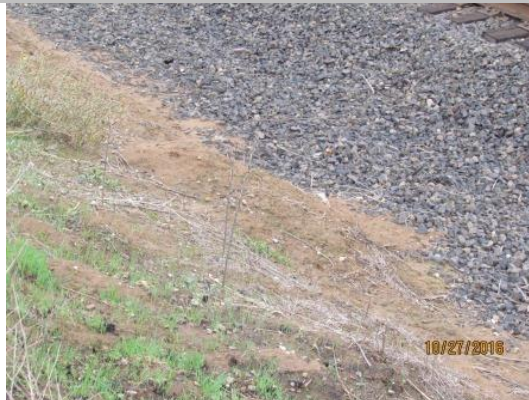
Photo 1 of 1 : SP\_2017\_RD0010\_163\_46\_20170316\_00015.jpg

View of squirrel holes on the landside slope and toe, no rodent activity was observed. Fall 2016.

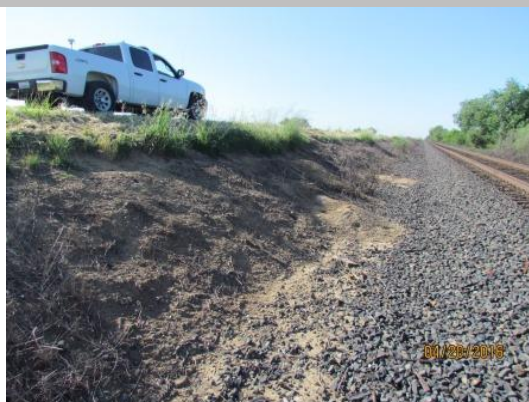
Photo 1 of 1 : SP\_2017\_RD0010\_163\_41\_20170316\_00012.jpg

View of multiple active ground squirrel holes on landside slope looking downstream.

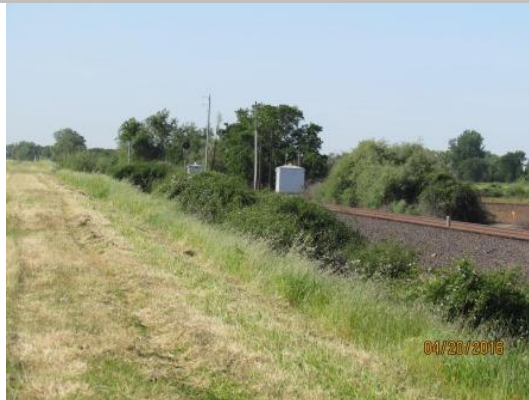
Photo 1 of 2 : SP\_2017\_RD0010\_163\_36\_20170316\_00009.jpg

View looking downstream landside of wild rosebushes that are blocking visibility at the toe. Spring 2016.

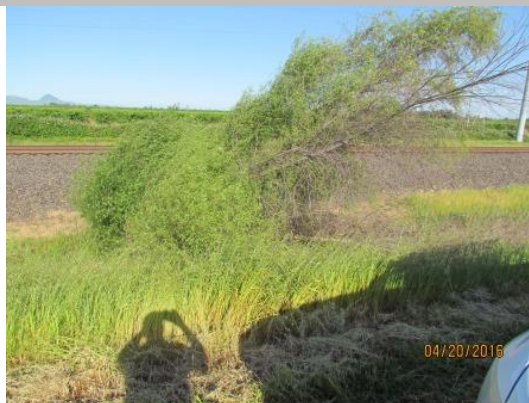
Photo 1 of 2 : SP\_2017\_RD0010\_163\_32\_20170316\_00005.jpg

View of a tree that needs to be removed. Small trees 4" in diameter at chest height should be removed before they get to big. View of landside. Spring 2016.

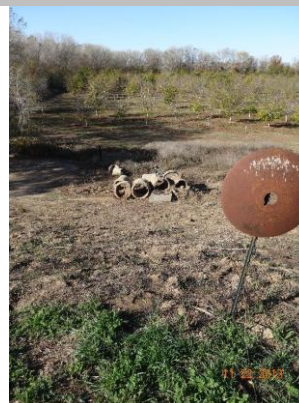
Photo 2 of 3 : UCIP\_SP\_2017\_24824\_44657.jpg

Overview of waterward slope--barrier placed at toe to discourage damage to crossing.

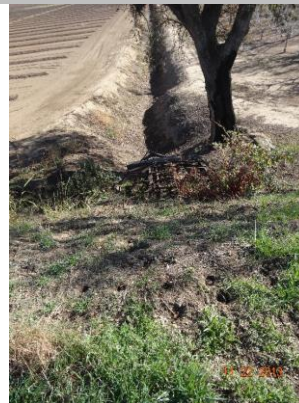
Photo 3 of 3 : UCIP\_SP\_2017\_24824\_44656.jpg

View of landward side--barrier used to discourage damage to crossing near toe.

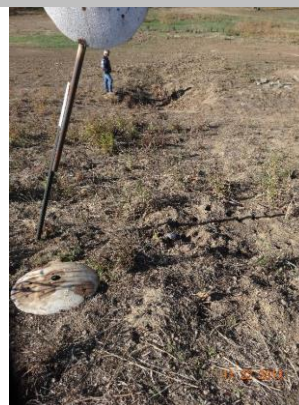
Photo 1 of 1 : SP\_2017\_RD0010\_164\_7\_20170316\_00002.jpg

View of waterward slope--burrow activity present.

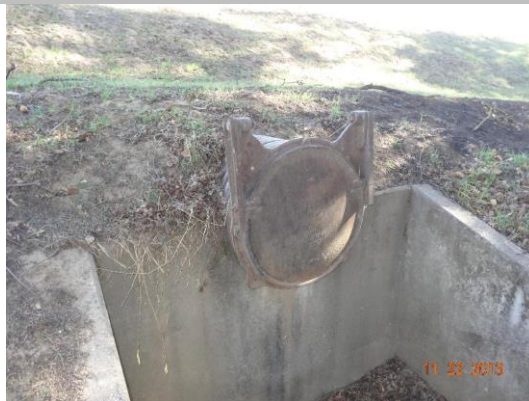
Photo 3 of 3 : UCIP\_SP\_2017\_24826\_44673.jpg

View of flapgate on concrete head wall on waterward side.

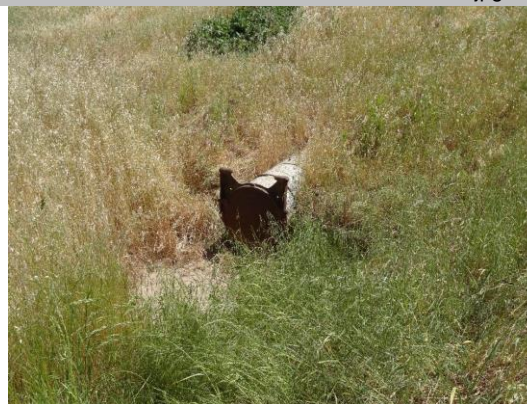
Photo 2 of 3 : UCIP\_SP\_2017\_24751\_44376.jpg

View of flap gate on waterward side.

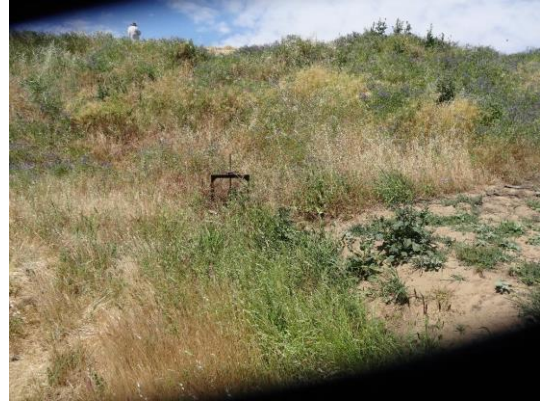
Photo 3 of 3 : UCIP\_SP\_2017\_24751\_44373.jpg

View of landward side--dense vegetation.

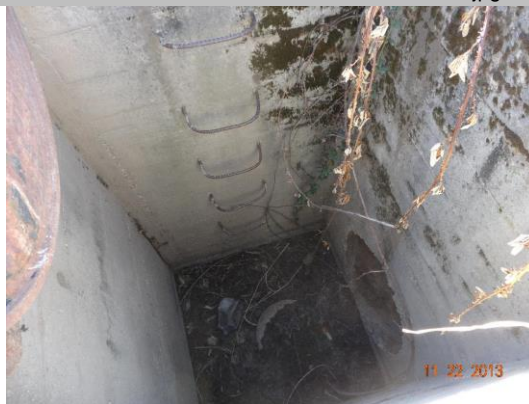
Photo 3 of 3 : UCIP\_SP\_2017\_24828\_44683.jpg

Inside view of concrete distribution box.

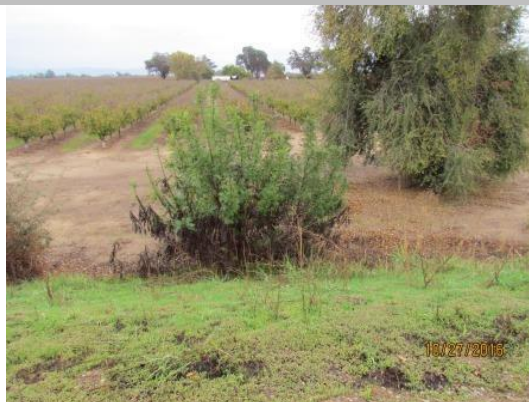
Photo 1 of 1 : SP\_2017\_RD0010\_164\_47\_20170316\_00019.jpg

View of a small tree at the toe of the landside.

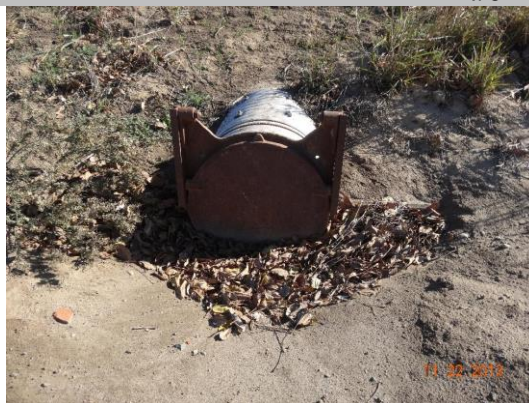
Photo 2 of 3 : UCIP\_SP\_2017\_27793\_51517.jpg

View of flap gate located on waterward side.

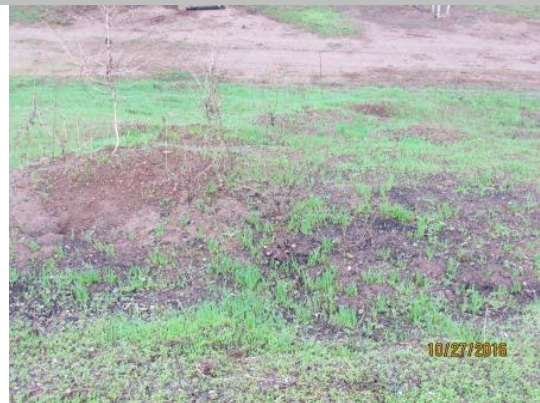
Photo 1 of 1 : SP\_2017\_RD0010\_164\_32\_20170316\_00012.jpg

View of rodent holes on waterside levee slope.

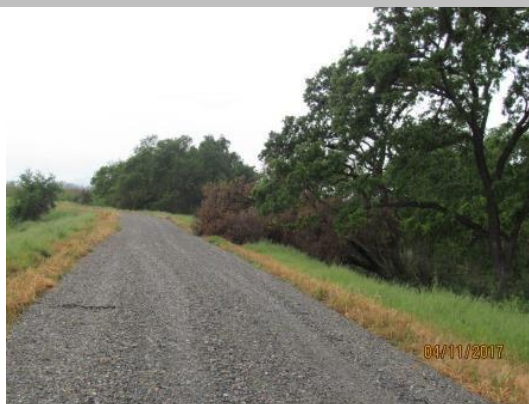
Photo 1 of 1 : SP\_2017\_RD0010\_164\_44\_20170414\_00114.jpg

View looking downstream of a fallen tree on the waterside slope, Spring 2017.

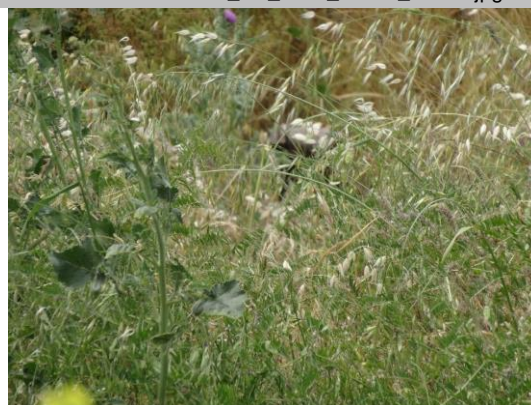
Photo 2 of 3 : UCIP\_SP\_2017\_24768\_44451.jpg

Dense vegetation on landward side.

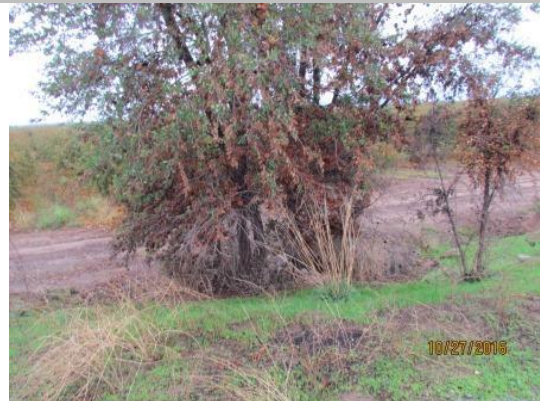
Photo 1 of 1 : SP\_2017\_RD0010\_164\_70\_20170316\_00035.jpg

View of tree on landside toe that need to be trimmed up five feet for visibility and access.

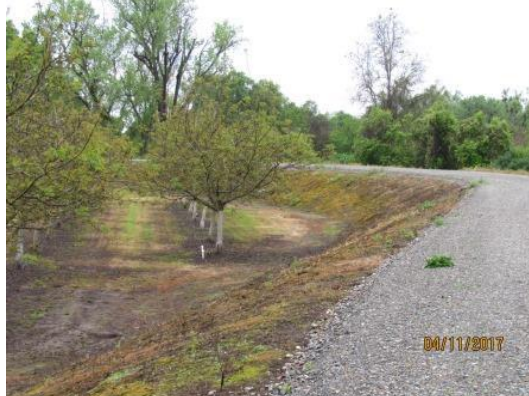
Photo 1 of 1 : SP\_2017\_RD0010\_164\_38\_20170414\_00107.jpg

View looking downstream of well maintained annual grasses, Spring 2017.

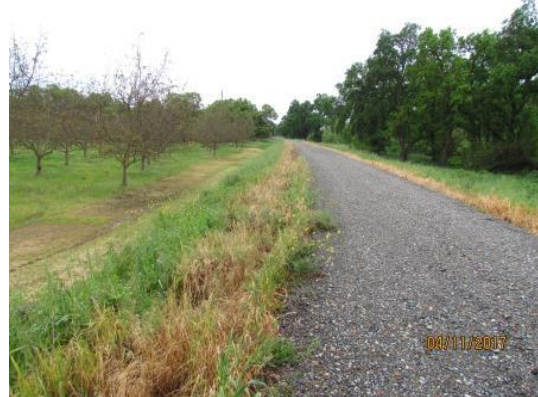
Photo 1 of 1 : SP\_2017\_RD0010\_164\_27\_20170414\_00108.jpg

View looking downstream of annual grasses on the slope that needs to be maintained, the crown and shoulders have been sprayed, Spring 2017.

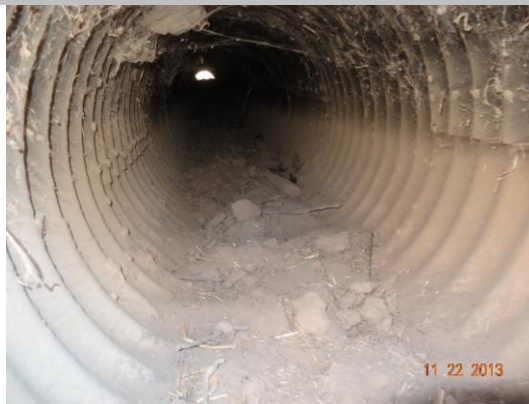
Photo 3 of 3 : UCIP\_SP\_2017\_24840\_44751.jpg

Internal view of pipe wall from waterward side.

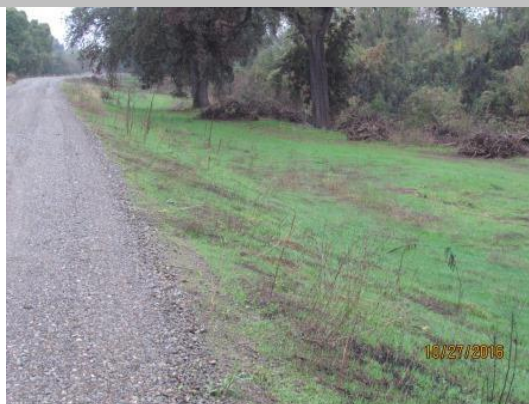
Photo 1 of 1 : SP\_2017\_RD0010\_164\_78\_20170316\_00041.jpg

View of the waterside looking downstream where the rodent hole have been backfilled. Fall 2016.

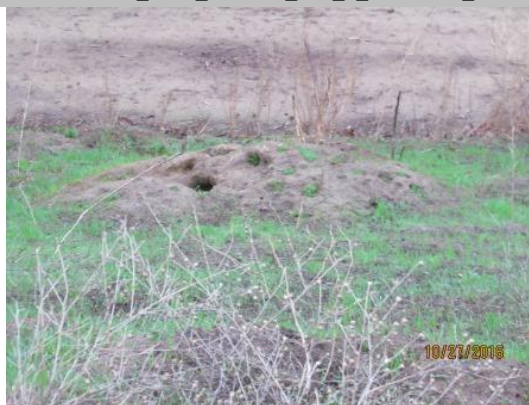
Photo 1 of 1 : SP\_2017\_RD0010\_165\_6\_20170316\_00001.jpg

View of waterside slope, no squirrel activity seen, but rodent holes need to be back filled properly. Fall 2016.
